JACOB TETREAU, MASC (2016)

RESEARCH SUMMARY

INVESTIGATION OF TWO DIFFERENT CULVERT REPAIR METHODS—GROUTED SLIP-LINERS AND INVERT PAVING

PERFORMANCE AND ASSESSMENT OF REHABILITATED STEEL CULVERTS

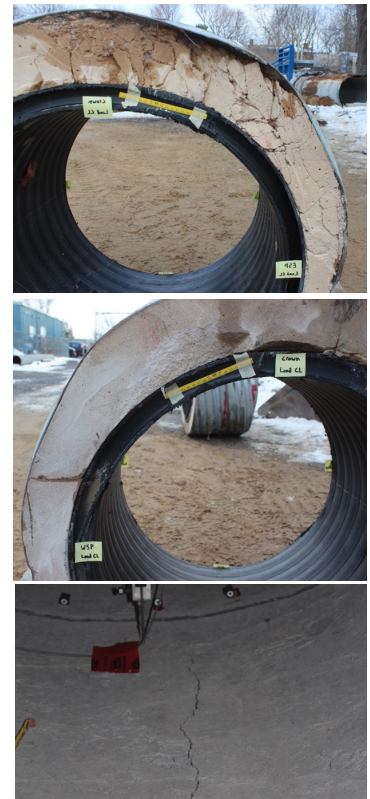
Different Portland cement grouts were examined for sealing the annulus between the liner and the steel culvert—low density aerated grout, and conventional high density grouts. The aerated grout had compressive strength < 2MPa, and experienced extensive shear fractures around grout-liner interface, and through the grout annulus. In contrast, the dense grout had much higher (>10MPa) strength, and had ultimate limit state controlled by tensile fractures at crown, springlines and invert.

Paving of the corroded steel at the base of the culvert had strength limit controlled by bending moments and fracture on the tensile face of the lightly reinforced concrete

Polyethylene slip liners installed with low density (upper) and high density (middle) grout; fracture in paved invert (lower).
