CALEB REGIER, MASC (2015)

RESEARCH SUMMARY

INVESTIGATION OF THE FAILURE MECHANISMS OF INTACT AND DETERIORATED CULVERTS

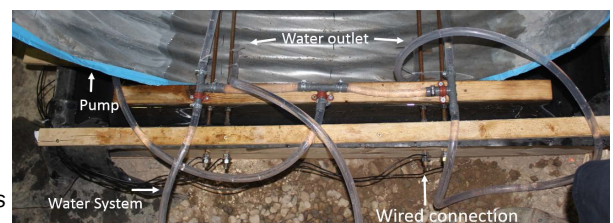
End of pipe bath showing electrodes

Previous tests on corroded metal culverts have relied on pipes exhumed from the field which has limited the nature and number of samples tested. Working in collaboration with Dr Allan Scott of the University of Canterbury, New Zealand, impressed current procedures were developed to simulate decades of corrosion in a few weeks. Pipes were immersed in a water bath filled up to the pipe haunches. Electrodes running parallel to the haunches concentrated corrosion at that level. Water flow was used to move corrosion products into a collection sump.
